TAB Journal

THE MAGAZINE OF THE ASSOCIATED AIR BALANCE COUNCIL • SUMMER 2012

Building Pressure and Leakage

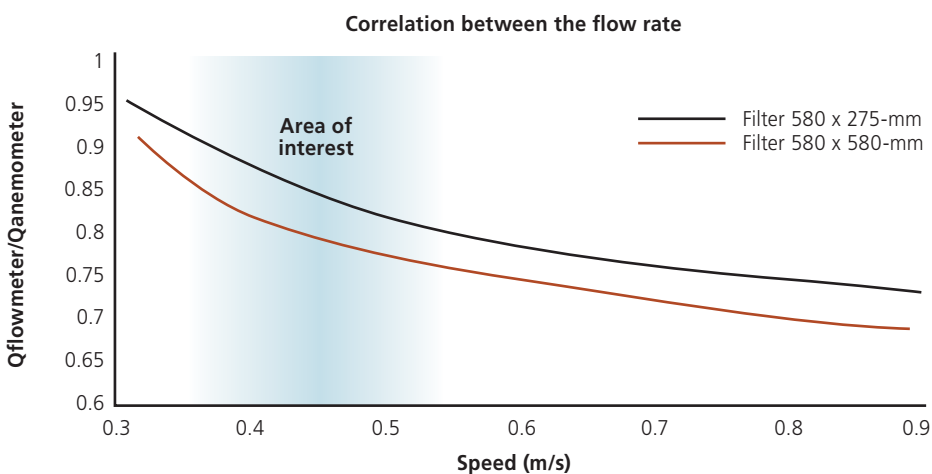
Figure 4. Relationship between airflow and air speed.
