TAB Journal

THE MAGAZINE OF THE ASSOCIATED AIR BALANCE COUNCIL • SPRING 2016

Troubleshooting *for Optimum System Performance*

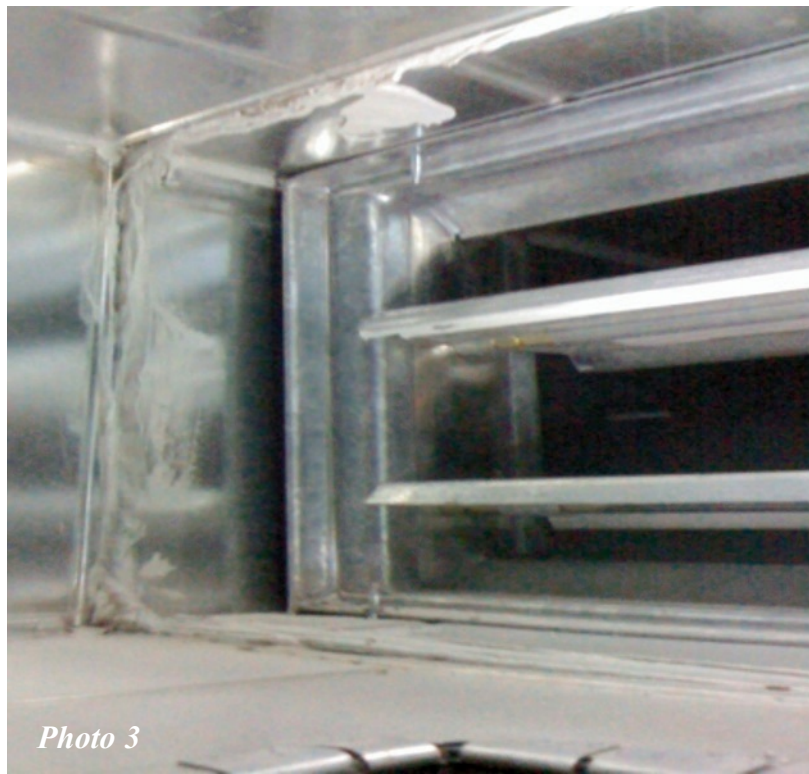
Photo 3

- **Testing of zone alarm events did not always shut down air flow as required:**
 - **Dampers appeared to be fully closed.**
Static pressure measurements indicated leakage. Bore scope pictures indicated improperly sized damper sections. (See photo 3).

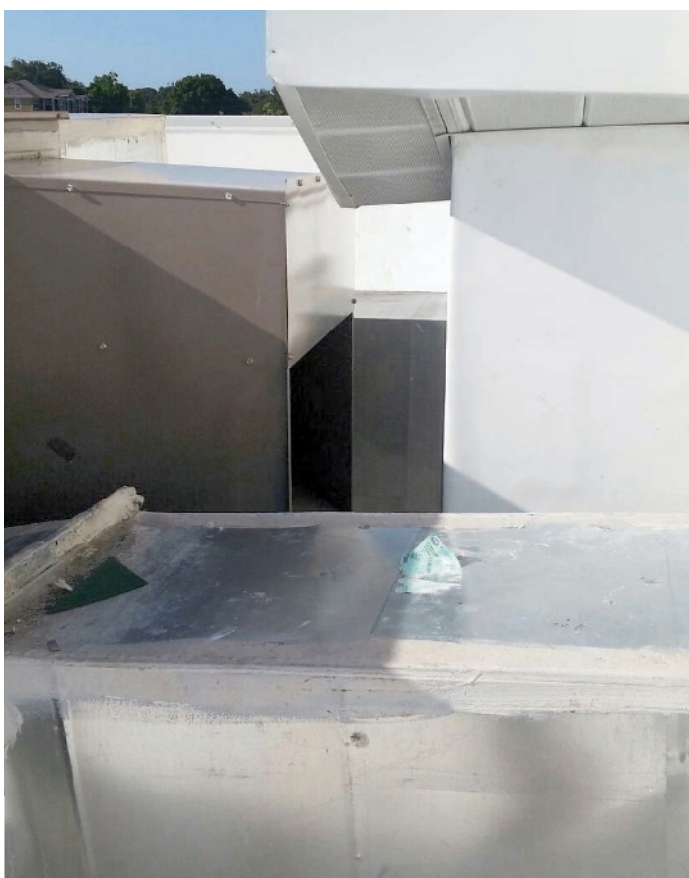
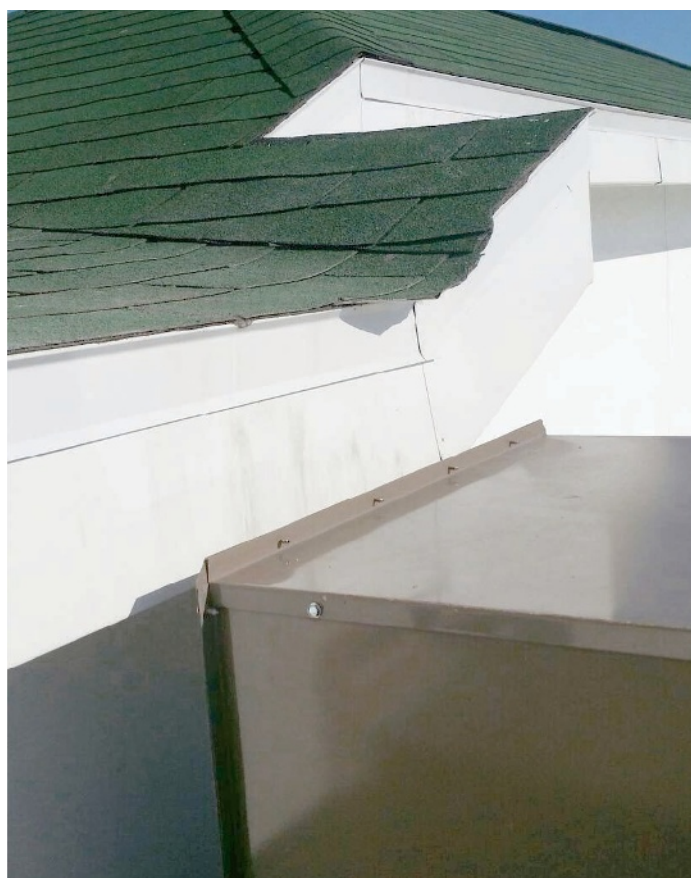
It is important to not forget rooftop units with outside air intakes. Location and accessibility is just as important in order to test and set. Included here are pictures of a recent project showing issues TAB firms have with accurately setting the outside air. Problems for the TAB firm service personnel include:

- Accessibility to test outside air
- No access to the motorized damper to adjust settings.
- Roof line and gutter route rain water to the top of intake.

Poor location/placement of a roof top unit (RTU), indicates the potential roof rain water being directed towards the outside air intake along with access issues for service.
