# TAB Journal

THE MAGAZINE OF THE ASSOCIATED AIR BALANCE COUNCIL • SPRING 2015

## Troubleshooting and Safety Considerations

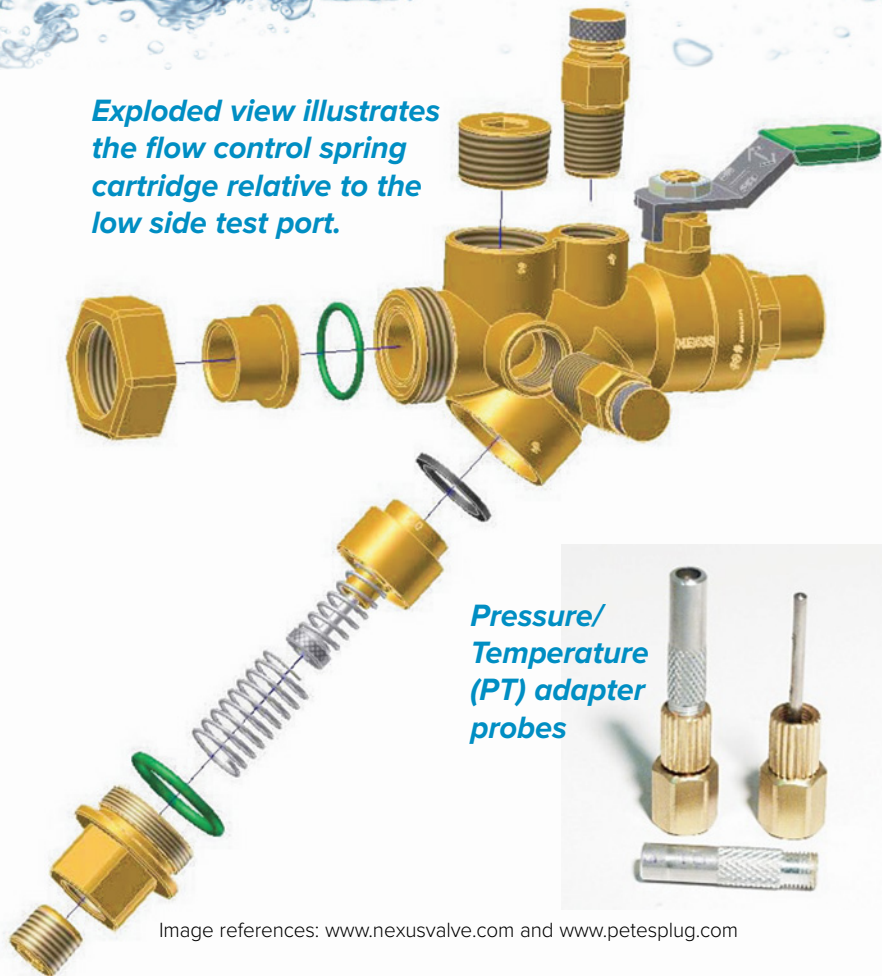
*Pressure/ Temperature (PT) adapter probes*

The low pressure drop was indicating a high flow rate, and not a low flow rate; the problem was caused by using a probe that was too long. Nexus was contacted and informed of the situation. The manufacturer’s representatives were not familiar with this situation and their operating and maintenance manuals do not reflect a potential problem arising by using an improperly sized test probe. The PT test probes should not exceed 1.5 inches in length to avoid this issue. 🌐

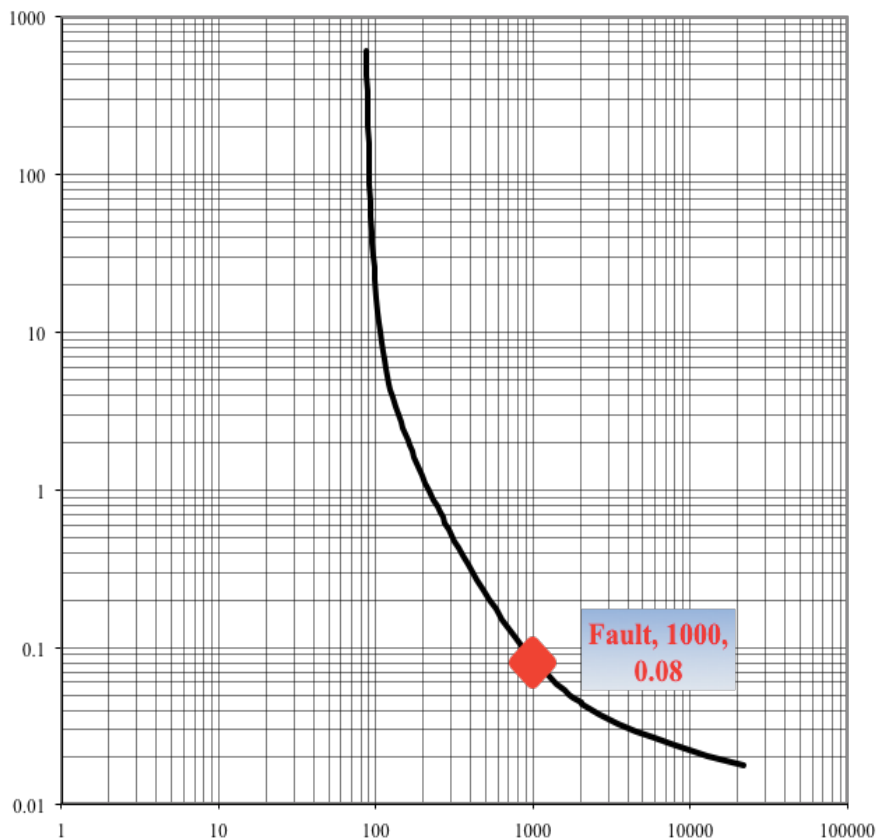
**FIGURE 1: 12,160 V Busway Fault**

In Figure 1, an open air 1000 Amp fault on a 40 Amp primary service is illustrated downstream of a 12,460 (12.kV) fused switch. The Y axis of the chart is time in seconds and the X axis of the chart represents fault current in Amperes. The arc flash incident energy in this situation is only 0.25 cal / sq. cm, which equates to a Hazard Risk Category (HRC) of 0. The prohibited boundary (36") to prevent a shock hazard is actually greater than the arc flash hazard boundary (6").

The second component of an arc flash is the duration of the arc. This is the most important factor in determining the intensity of an arc flash. A common misconception is that higher voltage equipment or higher amperage busways have a higher arc flash hazard. This may or may not be true. Often, the higher voltage and amperage systems produce arcing faults that have very high arcing fault currents, but the upstream overcurrent protection devices open and clear these faults very quickly. Therefore, the overall arc flash energy level (measured in calories / square centimeter) is relatively low for the energy that is available. Conversely, many points that are further along in an electrical distribution system, such as a motor control center or motor starter, can have relatively low available arc fault currents, but the overcurrent protection device settings do not clear the fault quickly. This results in longer arc fault duration and a much higher arc flash energy level. An example of these two scenarios is shown in the figures on the right and on page 12.

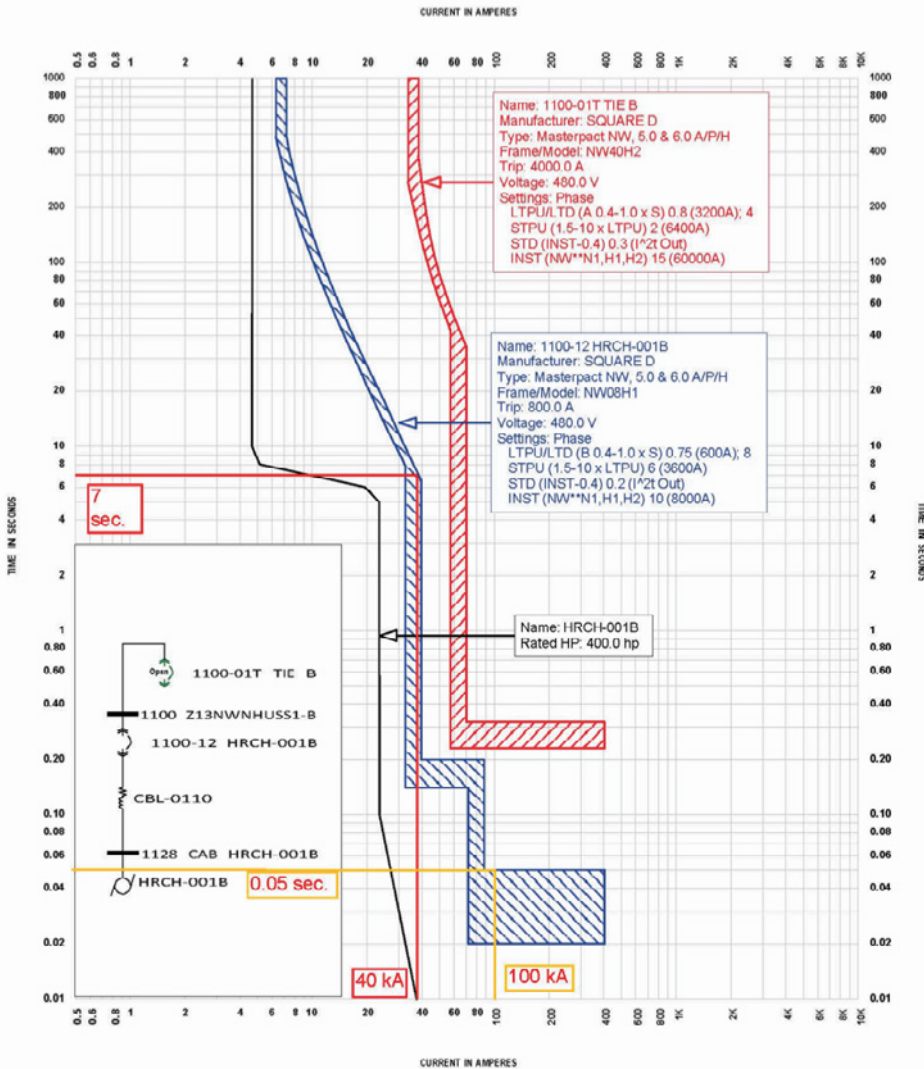
**FIGURE 2: Chiller Motor Starter Fault (Arc vs. Short Circuit)**

Figure 2 shows both a bolted fault and the arc fault that could be generated in a motor control center for a chiller. As noted, the bolted short circuit fault current is approximately 100,000 Amps. If that fault were to occur, the upstream overcurrent protective device (OPD) would trip in approximately 0.05 seconds. The

maximum arc fault current is actually calculated based upon the minimum short circuit current available which is 40,000 amps. At this level, the OPD trip time is approximately 7 seconds resulting in an arc flash energy level of 299 cal. / sq. cm at a boundary of 505 inches. This is a HRC of DANGEROUS—or no arc flash PPE is available for protection of personnel—within a radius of 42 feet from the equipment.

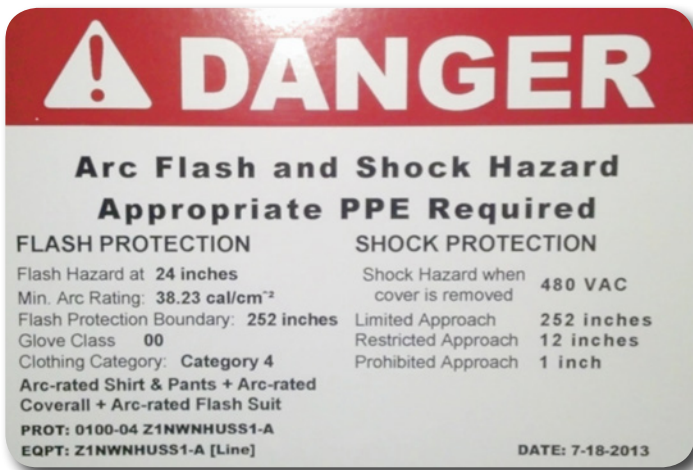
**FIGURE 3: Arc Flash / Shock Hazard Label**

So what does this mean for Test and Balance and Commissioning personnel? First and foremost is to understand the hazards that may be present around electrically energized equipment. While a large motor control center is typically more dangerous, do not discount the 10 HP motor starter disconnect switch that is commonplace in many facilities. Personnel must search out the facts and understand the hazards. To do this, a person must be able to read an Arc Flash Warning Label that should be posted on most new equipment. An example is shown in figure 3.

This label provides all of the required information in order to determine what is needed to be safe around a piece of equipment. The Flash Protection Boundary indicates the distance from the equipment where an arc flash could cause a second degree burn to bare skin (1.2 cal. / sq. cm.). Within this boundary, the stated HRC must be

utilized to determine arc flash PPE as shown on the label. The shock hazard is also listed. The limited approach for un-qualified personnel will typically be the same as the arc flash boundary. The restricted approach is determined by the voltage of the energized conductors. The minimum insulated glove class will be provided on the label if work within the restricted approach boundary is required (i.e. voltage and current measurements). The prohibited approach should never be entered except utilizing test instruments or insulated tools along with the proper PPE (i.e. voltage rated gloves).

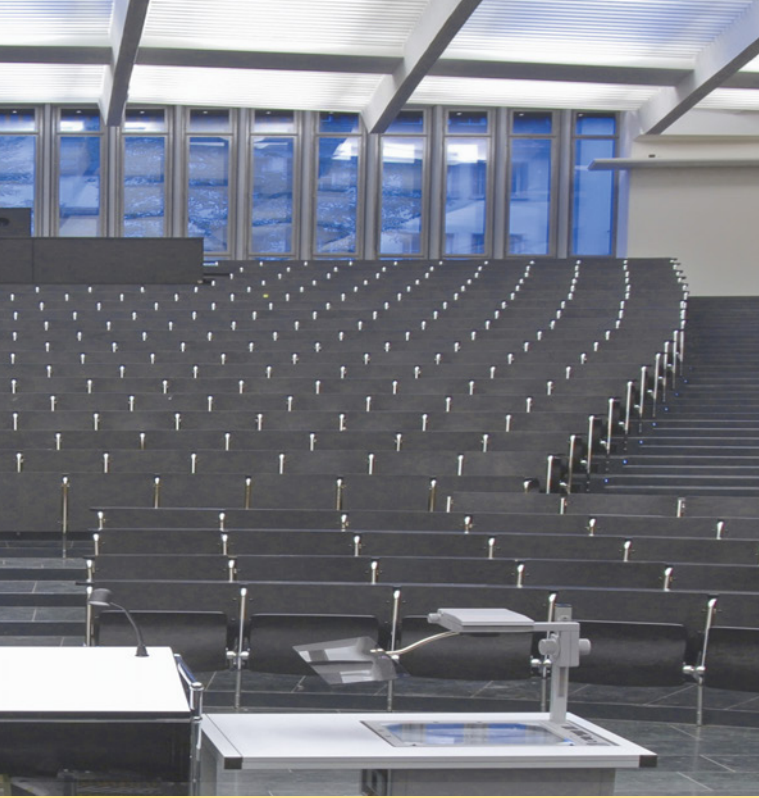
The balancing of the air devices had to be performed with scaffolding installed over the seating area...

Readings were then verified in the amphitheater. Due to the fact the scaffolding was removed, a lift was used to measure two of the 20” round supply diffusers. The other two 20” round diffusers in the middle of the space could not be measured without scaffolding. The two sidewall registers could be measured off a 6’ ladder. The two 20” round diffusers were measured with an airfoil probe. The K factor for this diffuser was previously established by duct traverse. The end diffusers tested at approx. 85% of design (within limits as established within an open area).
